Manhole Inspection Summary

Manhole # S33QQ_039MH

Insp Date: **4/23/07 10:40 AM**

Location Address: **2416 SAINT PAUL ST**

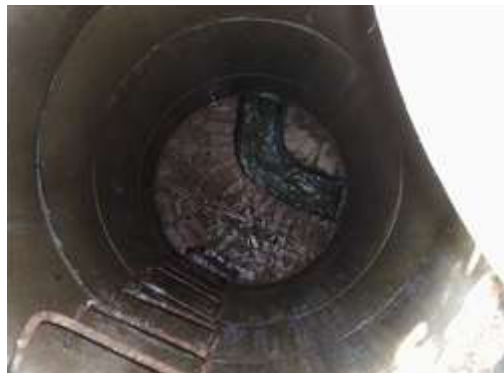
Top View

Corroded steps. Evidence of surcharge - Bench debris.

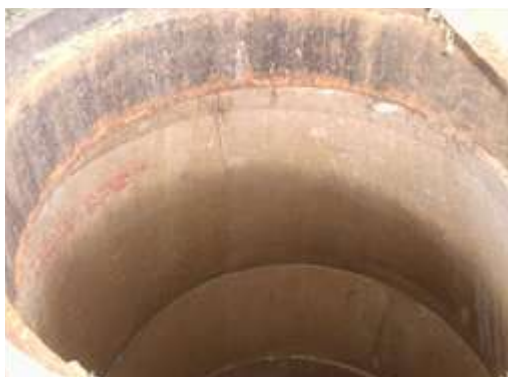
Defect

Frame offset. Adjustment root intrusion and infiltration. Corbel infiltration - other side.

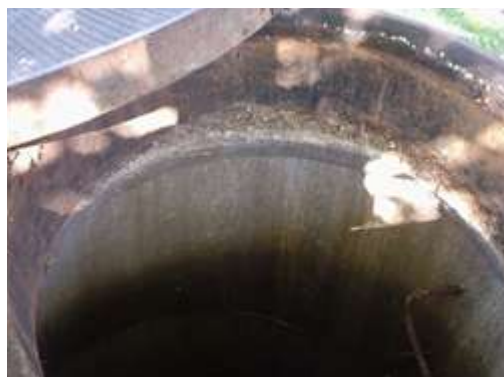
Defect

Frame offset. Adjustment and Corbel infiltration.

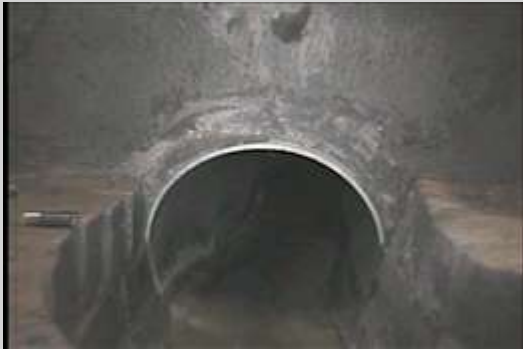
10 in. Circular Gravity Sewer Pipe Out @ 12 O'Clock

Invert Depth: **11.91** (ft.) Flow Characteristics: **Fast**

Deposits: ☒ None ☐ **Mud** ☐ Sludge ☐ **Debris** ☐ Grease

Infiltration: **None** Pipe Seal Cond: **Unknown**

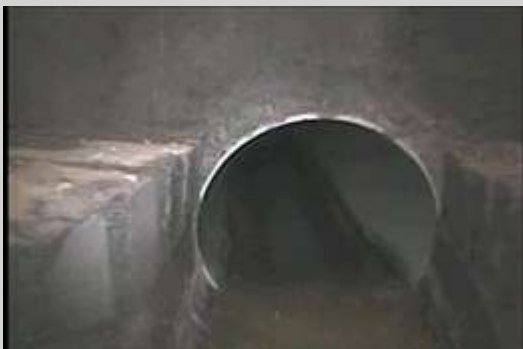
10 in. Circular Gravity Sewer Pipe In @ 3 O'Clock

Invert Depth: **11.81** (ft.) Flow Characteristics: **Fast**

Deposits: ☐ None ☒ **Mud** ☐ Sludge ☒ **Debris** ☐ Grease

Silt Depth: **0** (in.) Deposits Extent: **Light**

Infiltration: **None** Pipe Seal Cond: **Unknown**
